Inspection Report
Minerals Regulatory Program
May 9, 2013

Mine Name: Number 1 Clark Mine/Emeride	Permit Number: S/015/0074
Operator Name: Robert L. Clark	Inspection Date: May 8, 2013
Inspector(s): Wayne Western	Time:
Other Participants:	Mine Status: INA
Weather Condition: cool with overcast skies	Last Inspection: August 29, 2009
Bond Renewal Date: December 4, 2015	Bond Amount: \$11,900.00
Surface Ownership: SITLA	Mineral Ownership: SITLA
Last Year of Production: last annual report was for 2011	Acreage: 1.9 acres

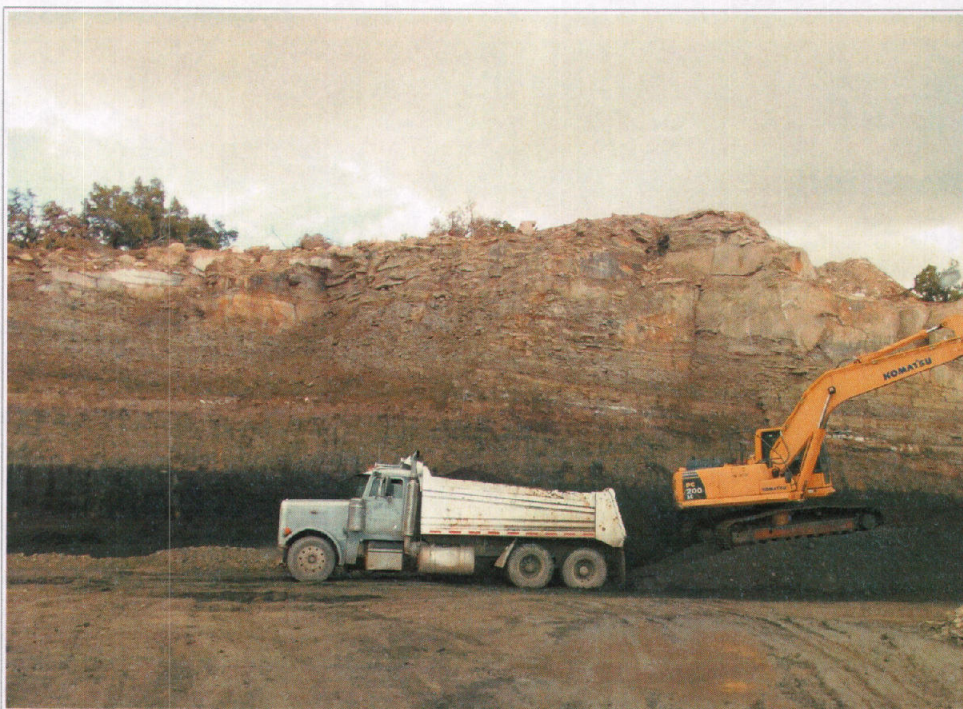
Truck being loaded with product.

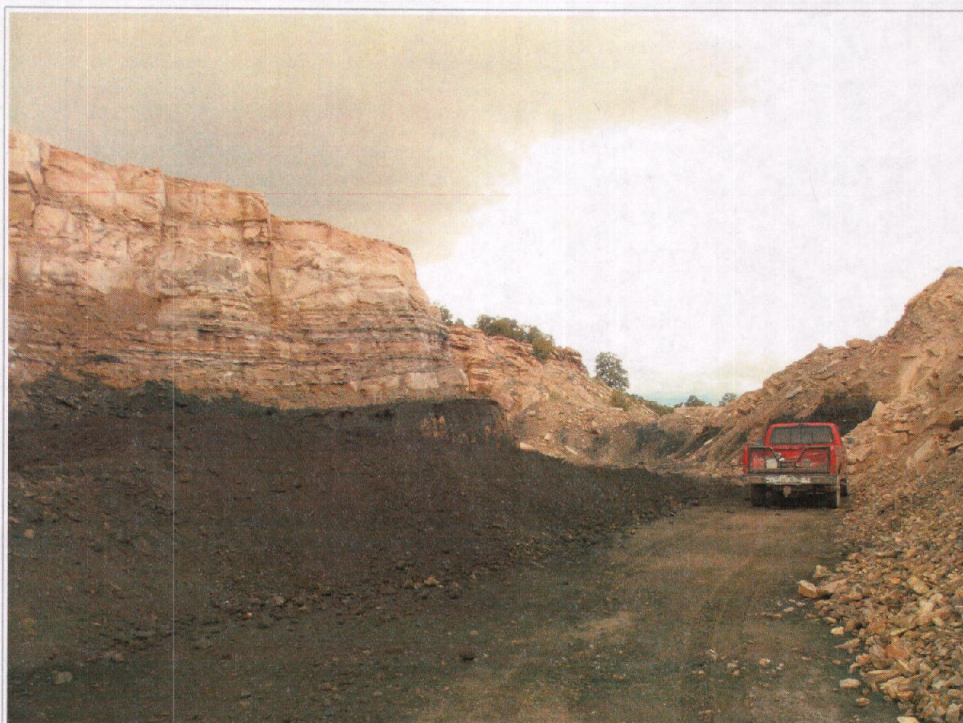
Pickup truck used to support operations.

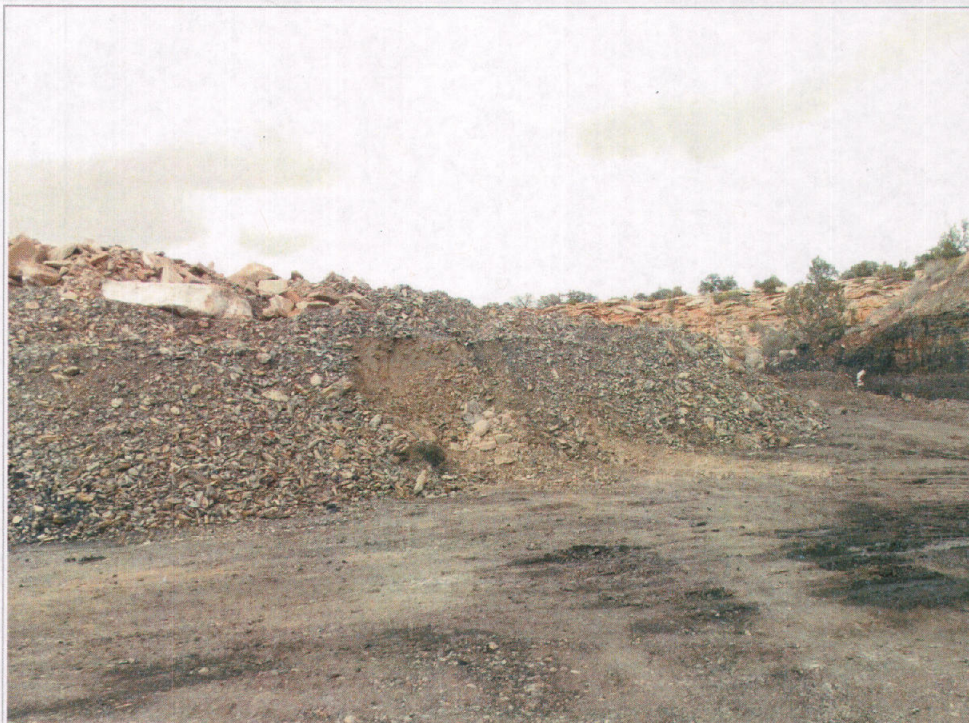
Overburden material

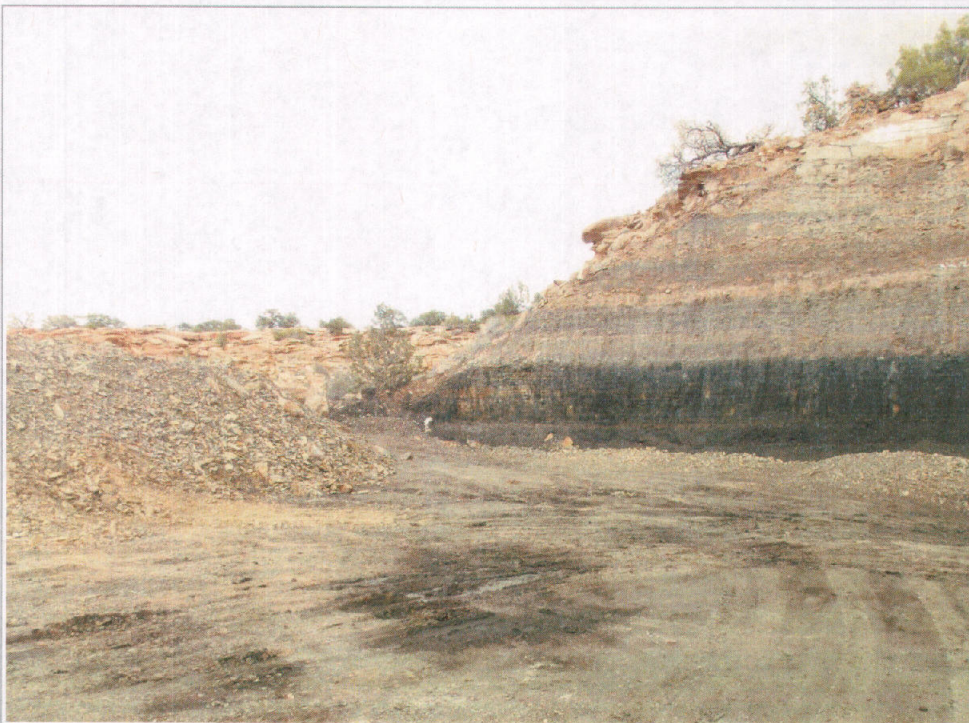
The site does have step highwalls which will be reclaimed during reclamation.

Overburden material and highwall.
